Emergency Service Bulletin

Title: Motor Arm Compatibility and Identification Requirements

Date: March 2026

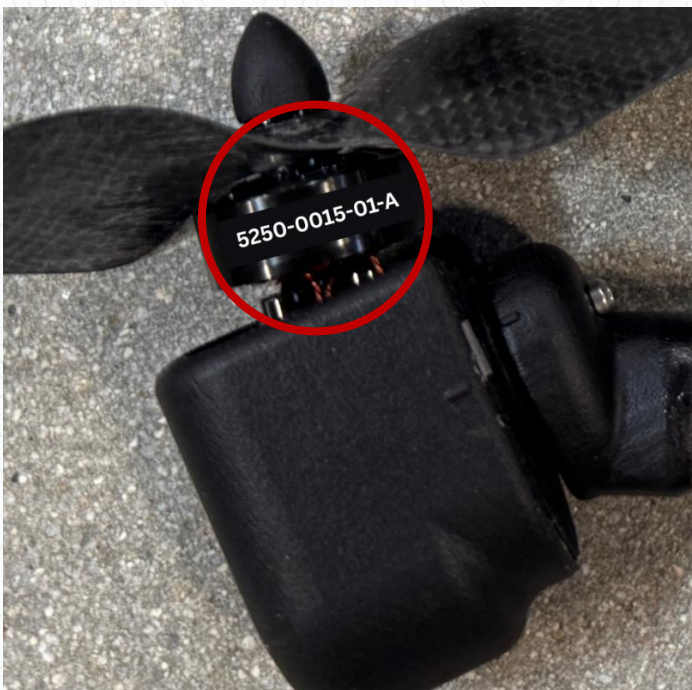
Figure 1 — Motor Part Number “-015”
(Old Motor Design)

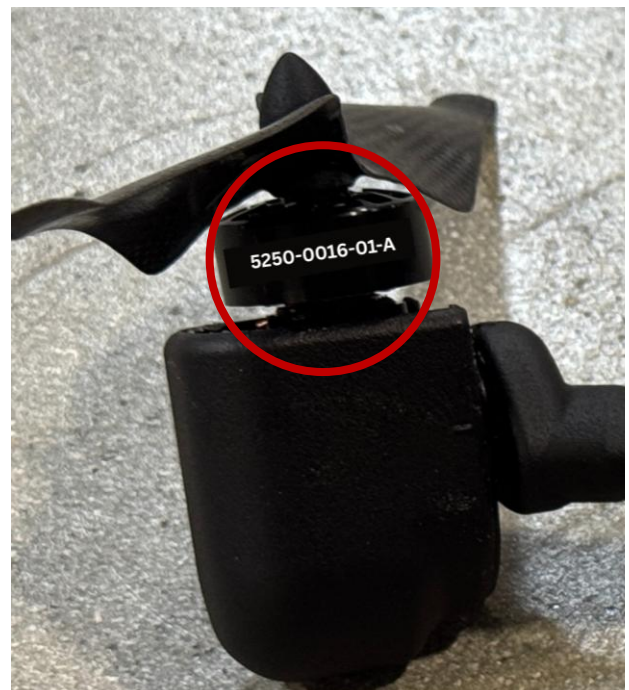
Figure 2 — Motor Part Number “-016”
(New Motor Design)

If a **-016-01/02 motor is installed**, the opposite motor arm must **also contain a -016-01/02 motor**.
